**APPENDIX H**

**RESULTS OF ASBESTOS AND LEAD TESTING**

RE: Asbestos Building Inspection – Old Lincoln Theatre, Baton Rouge, LA  
AEC File No.: 09-041

At your request, Advanced Environmental Consulting, Inc. (AEC) mobilized a team of professional staff members to conduct an asbestos, lead-based paint and lead in drinking water inspection at the referenced building. The inspection was conducted in accordance with applicable regulations and industry accepted practices on February 10, 2009 by Glenn Johnson, Louisiana Department of Environmental Quality (LDEQ) inspector number 9I00130 and Mr. Lanny Herring, LDEQ Lead-based paint Risk Assessor number Pb09RA00088.

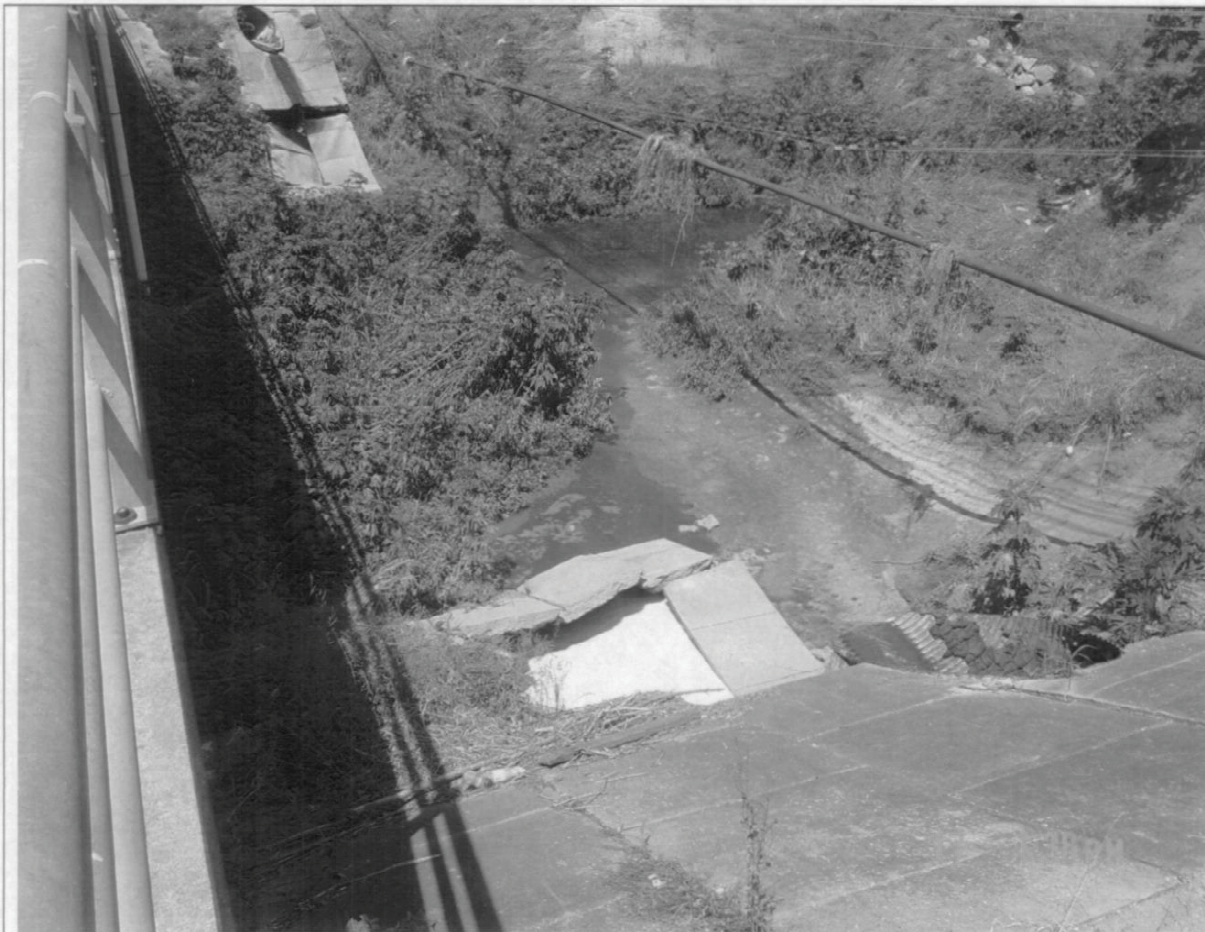
Photo #: 1 of 5 Date: 05-17-2007

1. The treatment system treats water from a car wash.
2. The facility has a permit to discharge commingled treated vehicle wash and sanitary wastewater totaling less than 25,000 gallons per day.
3. A DMR review revealed that the last DMR turned into our files was in 2001.
4. The discharge water is a green color. There was no smell, no oily sheen and no solids present.
5. Housekeeping at the facility appeared to be satisfactory at the time of the inspection.

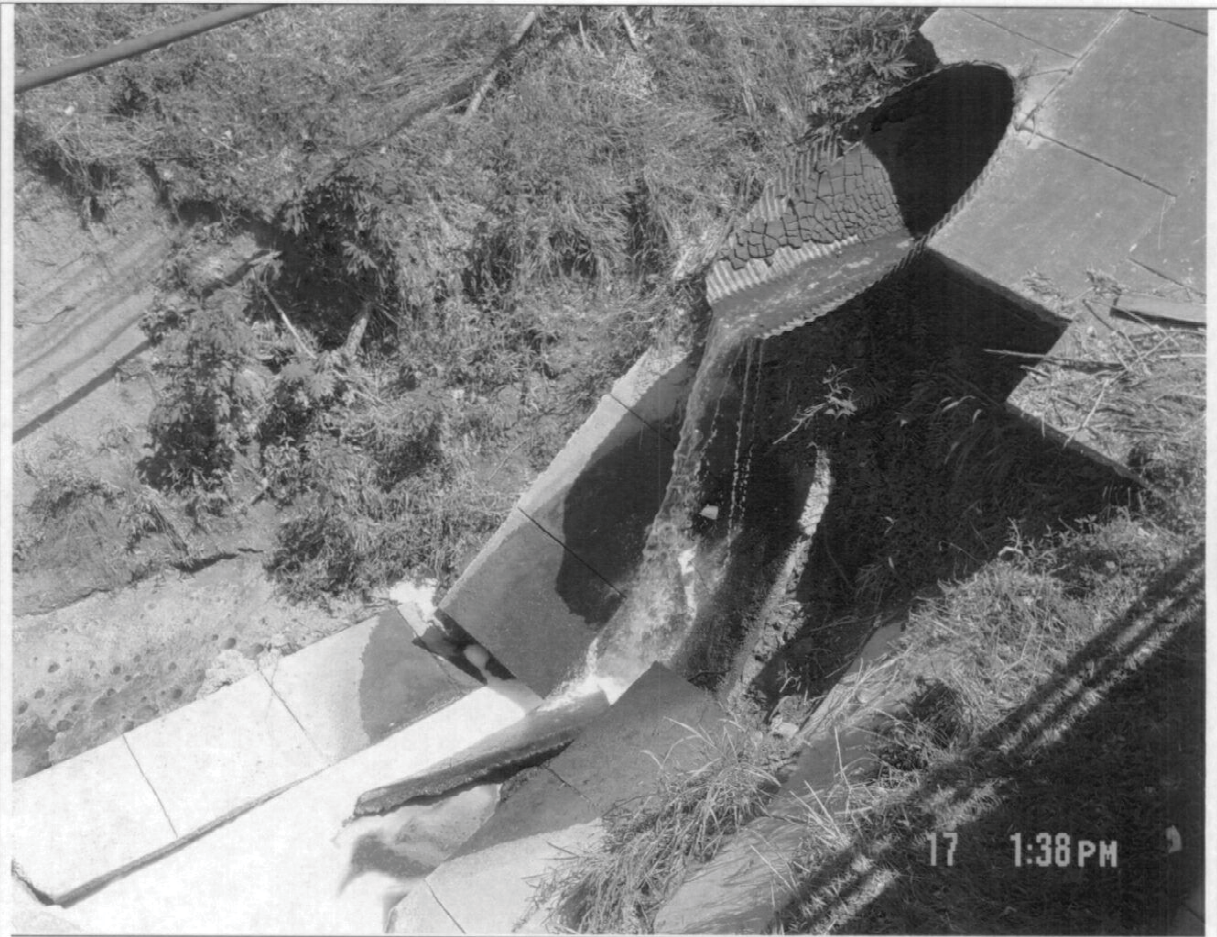
Photo #: 2 of 5 Date: 05-17-2007

1. The treatment system treats water from a car wash.
2. The facility has a permit to discharge commingled treated vehicle wash and sanitary wastewater totaling less than 25,000 gallons per day.
3. A DMR review revealed that the last DMR turned into our files was in 2001.
4. The discharge water is a green color. There was no smell, no oily sheen and no solids present.
5. Housekeeping at the facility appeared to be satisfactory at the time of the inspection.

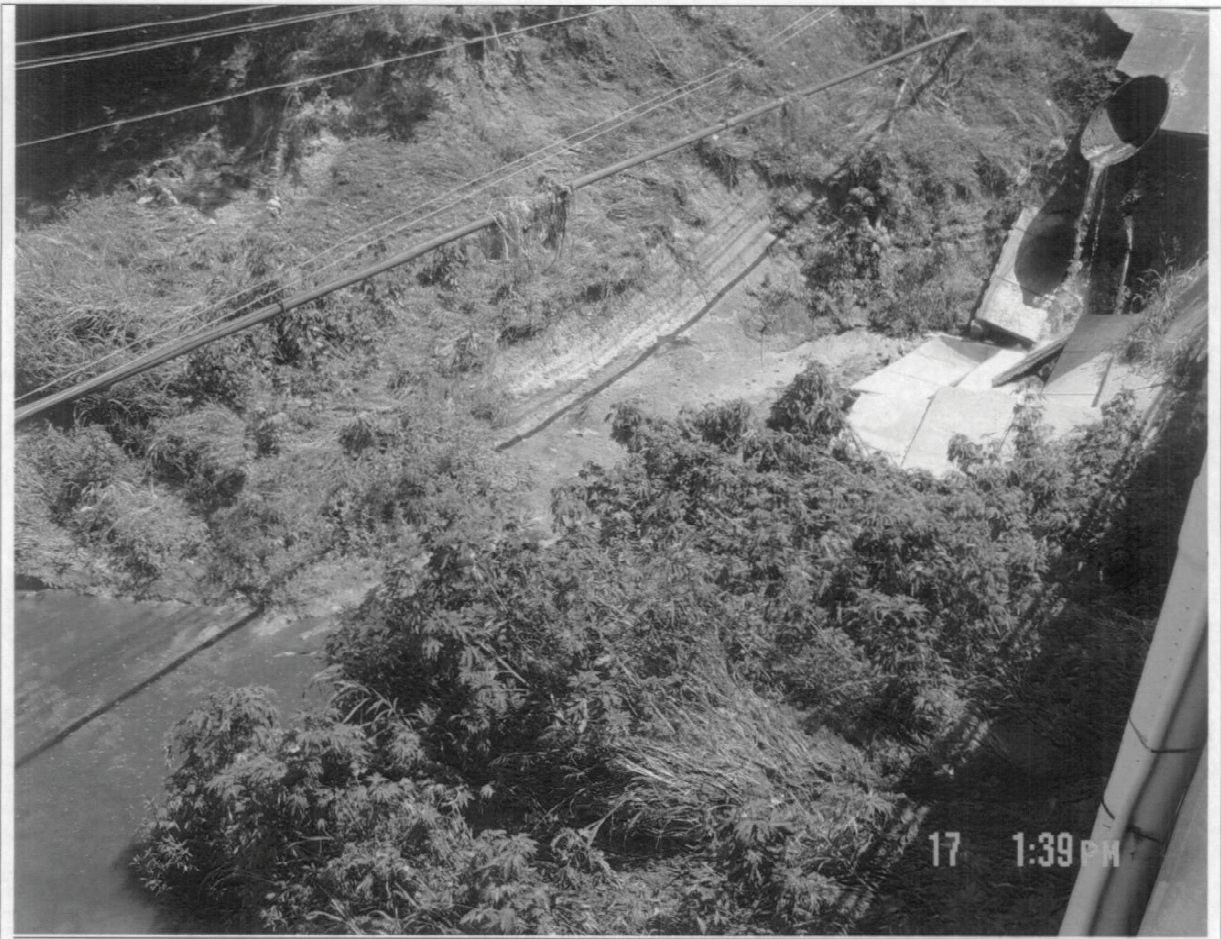
Photo #: 4 of 5 Date: 05-17-2007

1. The treatment system treats water from a car wash.
2. The facility has a permit to discharge commingled treated vehicle wash and sanitary wastewater totaling less than 25,000 gallons per day.
3. A DMR review revealed that the last DMR turned into our files was in 2001.
4. The discharge water is a green color. There was no smell, no oily sheen and no solids present.
5. Housekeeping at the facility appeared to be satisfactory at the time of the inspection.
